Description: LED Tail Lights

Part Number: 311213, 311214, 311215, 311216, 311217, 311218, 311219, 311220

Application: 2014 and up Chevy Silverado/ GMC Sierra 1500 2015 Chevy Silverado/GMC Sierra 2500, 3500

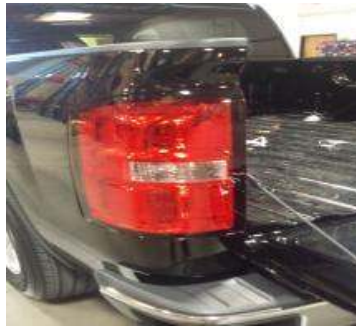
Start by opening your tailgate.

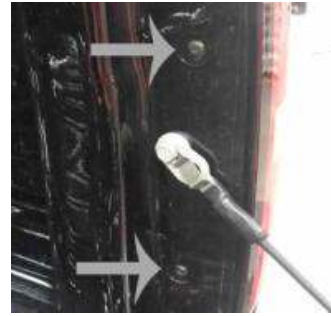
Remove the 2 Torx screw holding
the taillight in.

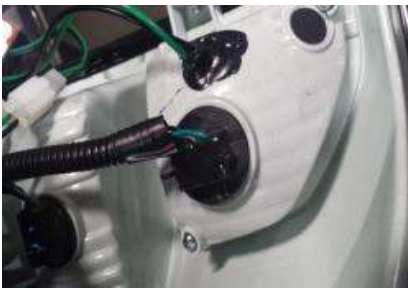
Remove your stock sockets from
the back of the light.

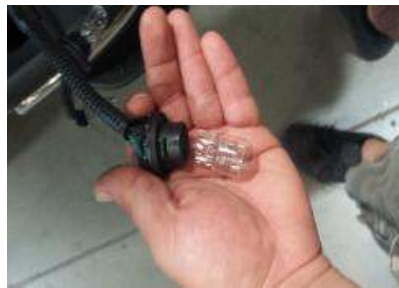
Once you have removed the sockets
from the housing. Remove the bulbs
from the sockets. Leave the reverse
bulb alone.

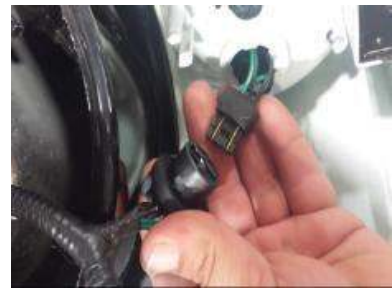
Next plug the connectors into your
stock socket. Be sure to line
the black wire up on the same
side on both the socket
and connector.

Twist your connectors into the new
housing and reinstall the
taillight back on the vehicle the
same way you removed it.

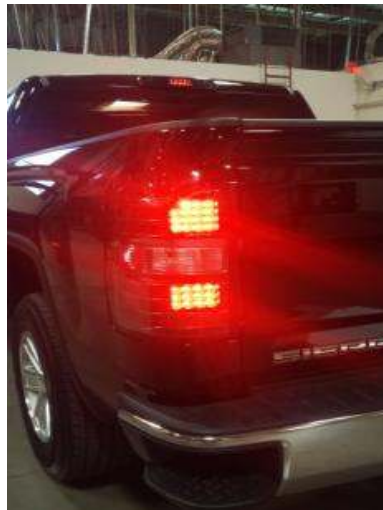
Test all functions of the light
before driving on public
highways.
